CASE STUDY

Bringing Balance to Net Metering Site Power Quality

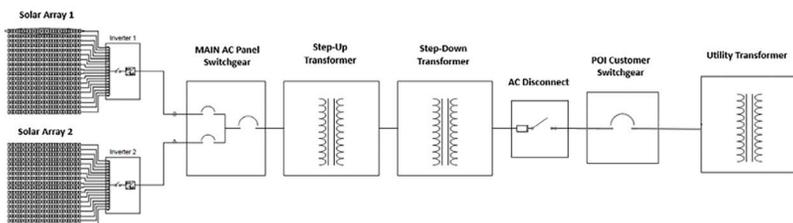
Figure 1

A net metering site customer with 250kW of ground-mounted solar arrays was reporting power quality issues to its local utility. The site’s system configuration included a grounded Wye-Delta step-up transformer and a Delta-grounded Wye step-down transformer to the point of interconnection (POI), as shown in Figure 1.

The combination of the transformer configuration and the position of the Delta transformation essentially created a grounding bank, resulting in an imbalance condition as well as being a zero sequence source. Grounding banks are zero sequence sources that can lead to other factors that impact grid operation, such as incorrect meter readings, protective relays and the potential for ferroresonance.

Replacing the Delta-Wye step-up and step-down transformers with grounded Wye-grounded Wye transformer configurations based on the utility's suggestion.

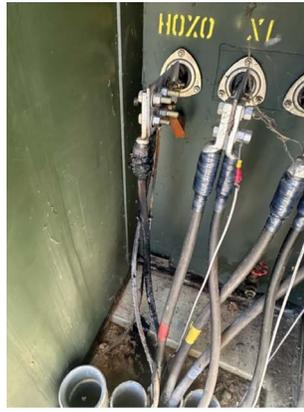
Figure 2

The power quality analysis equipped the utility with several key insights:

- The neutral cable was being overloaded with a significant amount of zero sequence current — approximately 430A of sustained current was flowing through it.
- The current phase angles were significantly imbalanced, resulting in the overheating and melting of the transformer's neutral cable.
- The utility transformer was exposed to sustained electrical stress that was shortening its lifespan.

Replacing all secondary cables to the POI switchgear. This was necessary because of the overloading damage to the neutral cable and related conductors.

Replacing the entire utility transformer. This was an added safety precaution, as it was exposed to excessive heat, electrical stress and located near pedestrian foot traffic.

Permanently applying a mounted power quality monitor to get ahead of these issues before they become a problem.
