CASE STUDY

Reshaping Capacitor Bank Function to Correct Low Power Factor

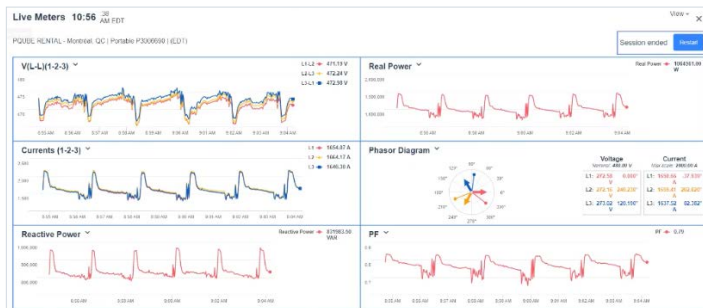
Figure 1: Data pulled from live meters. Every two minutes, the aluminum extrusion pressing cycle occurred, as seen in current peaks, voltage drops, and increases in power factor and kVAR. Such data proved instrumental in understanding the application and load.

The Power System Analysis detected and determined that the manufacturer's existing power factor correction equipment was not adequately compensating for the extrusion process's repetitive and rapid load changes. This dynamic load profile led Powerside to develop a unique, custom solution.
