CASE STUDY

Preventing Imminent Cable-Termination Failure with Early THD Detection

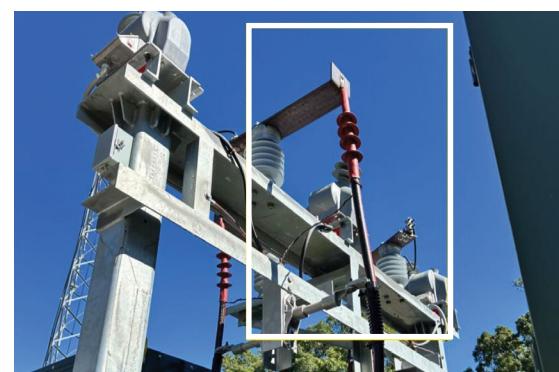
To investigate safely, the utility de-energized the suspect equipment to rule out other energy sources (Fig. 1). But upon re-energizing, the abnormal THD levels returned — along with the same hot line sniffer-detected electrical discharge — signaling that the root cause was still active and unresolved.

Figure 1: Equipment with elevated levels of total harmonic distortion

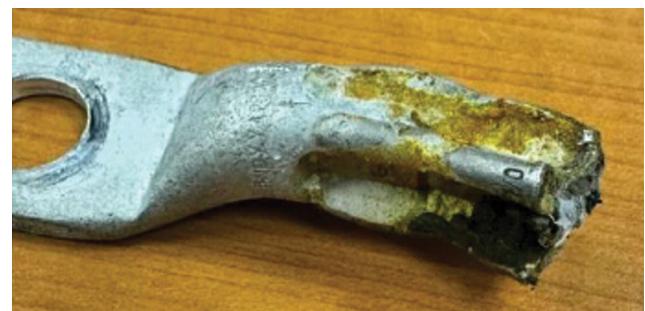
Because the issue was identified early — before catastrophic failure — a radio-frequency interference (RFI) sniffer tool was used to pinpoint the source of the electrical discharge. This tool quickly uncovered the issue: a badly crimped cable termination.

A teardown of the termination confirmed the diagnosis. The crimp was not uniform, showing discoloration and carbon buildup (Fig. 3).

Figure 3: A poorly implemented, nonuniform crimp on the cable termination caused discoloration and was the culprit of electrical discharges that would've led to cable failure

This finding reinforced a critical best practice in both overhead and underground installations that [Powerside Engineering Services](#) always double-check: Crimp tools must be properly calibrated, and correct crimping techniques must be consistently applied. Even small deviations can introduce power quality issues.

Take corrective action to ensure the issue was fully mitigated
